Inspection Report

Property Address:
12345 Sample Street
Baton Rouge La.

A+ Precision Inspection, LLC

Date: 10/21/2009	Time: 12:00 PM	Report ID: 123 Sample
Property: 12345 Sample Street Baton Rouge La.	Customer:	Real Estate Professional:

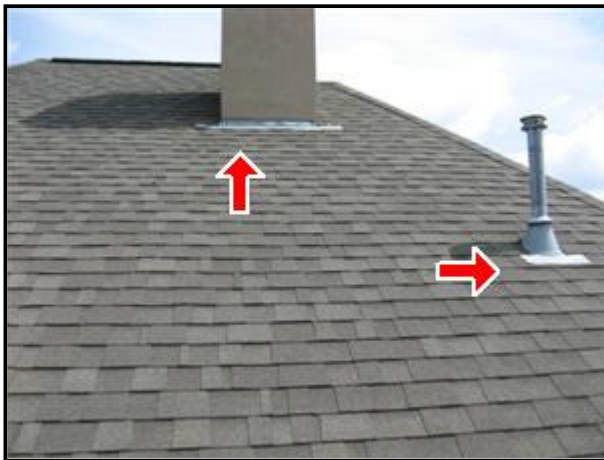
1.2 Picture 1

🏠 The tacks in on the two metal flashing positioned on the back roof should be caulked to prevent leaking in the future. There is no evidence that there is a present leak.

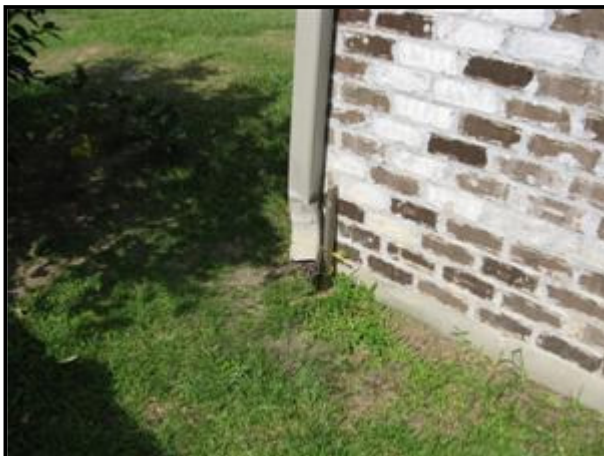
1.3 Picture 1

Several of the downspouts are bent possibly restricting water flow.

🏠 It is recommended all gutters discharge at least 4 feet from the house.

Recommend all gutters and downspouts be cleaned of debris.

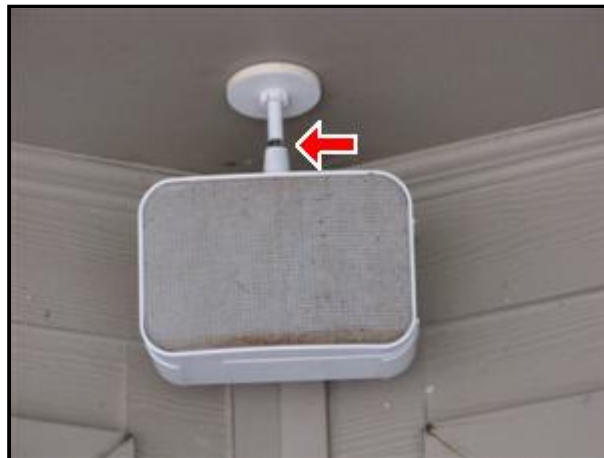
2.3 Picture 1

The speaker in the corner of the patio is hanging by the wires. This is minor maintenance.

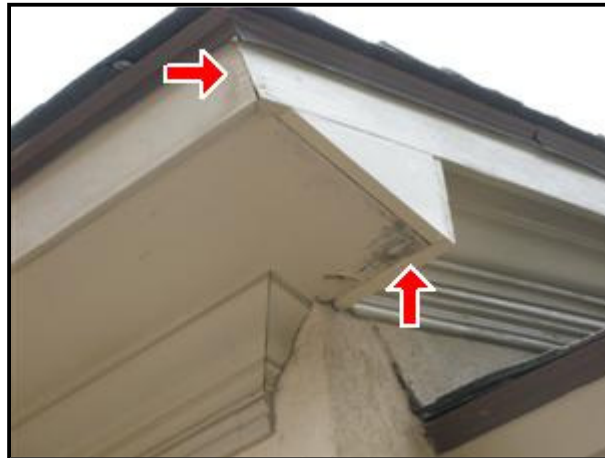
2.5 Picture 1

There is some soft wood decay on the back corner fascia and soffit by the patio.

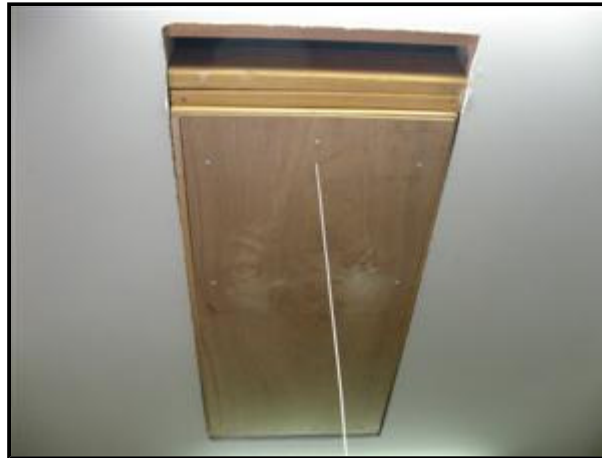
3.0 Picture 1

🏠 The ceiling has a gap by the pull down door in the storage room.

The ceiling has a gap by the pull down door in the storage room.

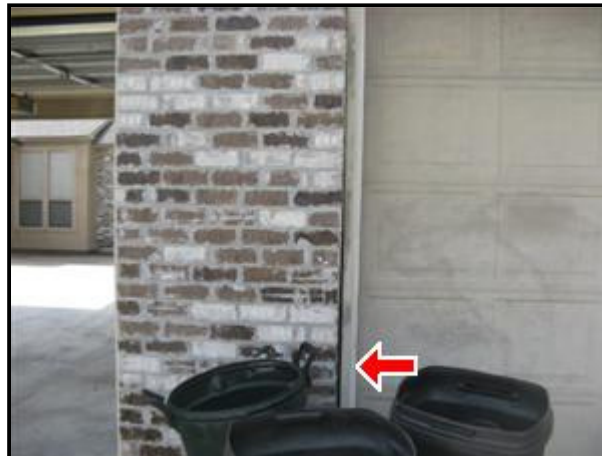
3.3 Picture 1

🏠 The trim around the metal door for the small storage room should be sealed.

The trim around the metal door for the small storage room should be sealed.

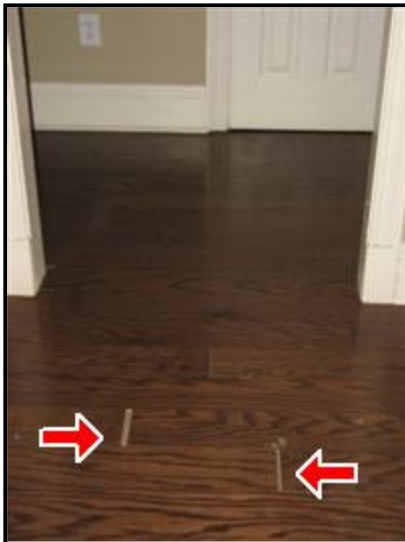
4.2 Picture 1

Wood floor has a gap by the door to the hallway and in the hallway.

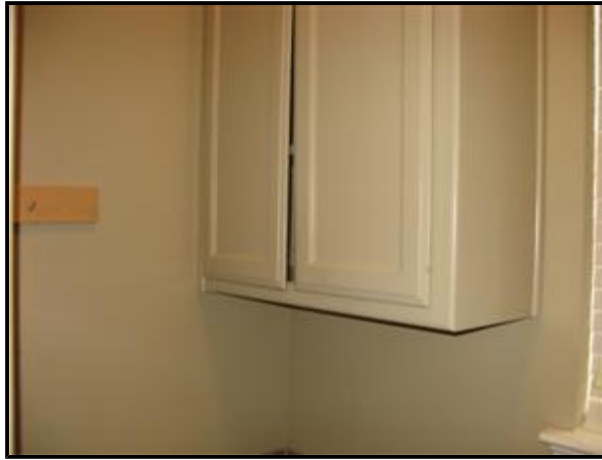
4.4 Picture 1

A couple of cabinet doors in the washer/dryer room do not close flush against the stop.

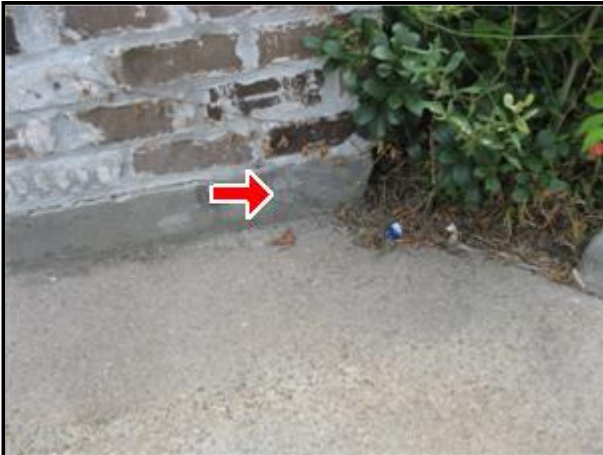
5.0 Picture 1

- 🏠 There is evidence of potential wood destroying insects. Recommend qualified pest control technician evaluate and address.

There is evidence of potential wood destroying insects. Recommend qualified pest control technician evaluate and address.

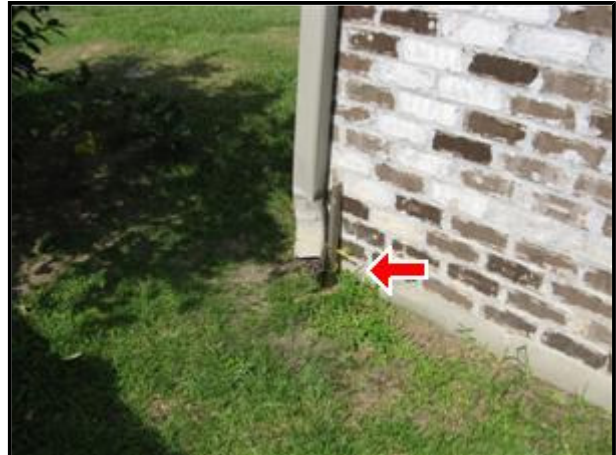
5.0 Picture 2

There is some minor corner cracking on slab. Recommend cracks be sealed with mortar or caulk.

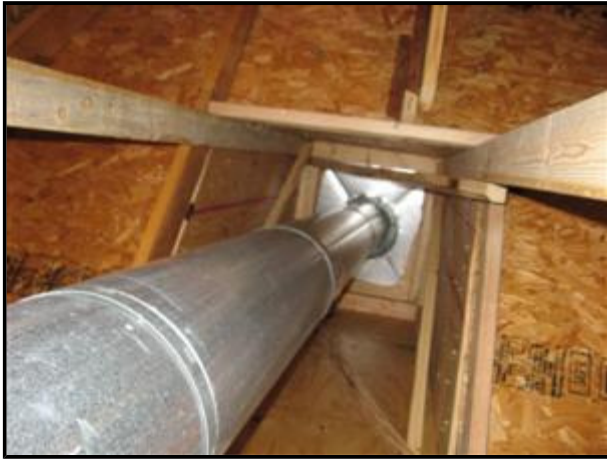
5.4 Picture 1

Roof structure is sound.

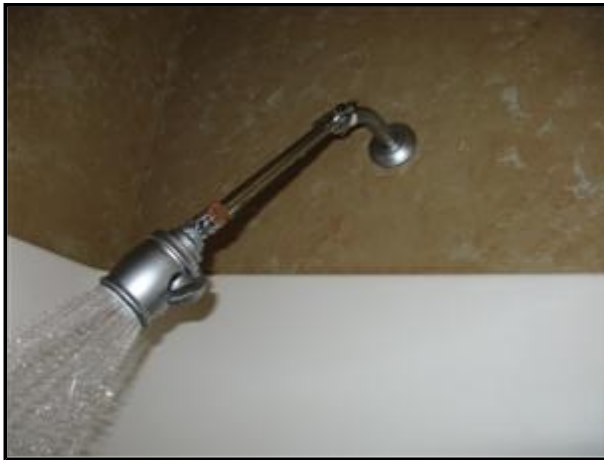
6.1 Picture 1

The shower head on in the master bathroom sprays water up the wall. (Picture 1)

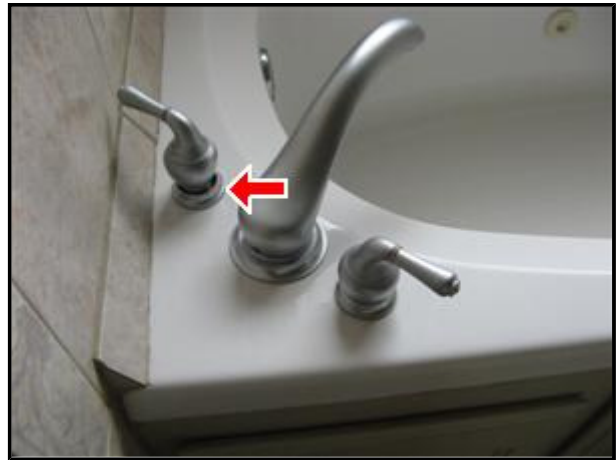
6.1 Picture 2

The trim ring for the hot water valve has a gap in it. (Picture 2)

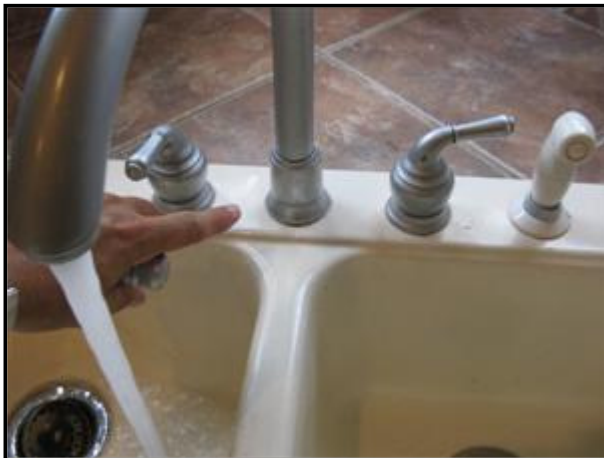
The kitchen sink spigot does not swivel properly. (Picture 3)

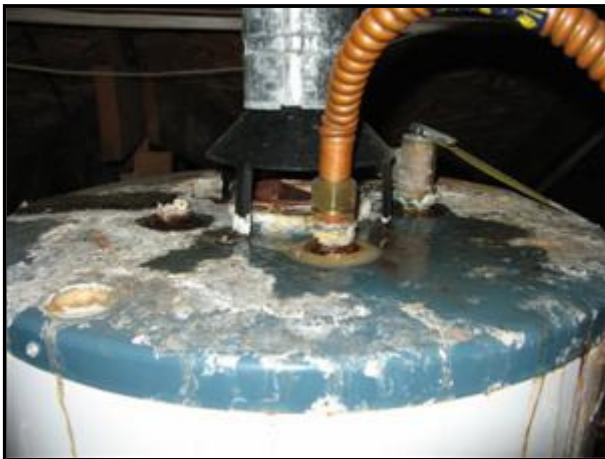
6.2 Picture 1

The hot water heater is leaking from the top of the unit. It is running down into the pan and out the drain to the outside. Recommend a qualified technician evaluate and repair or replace.

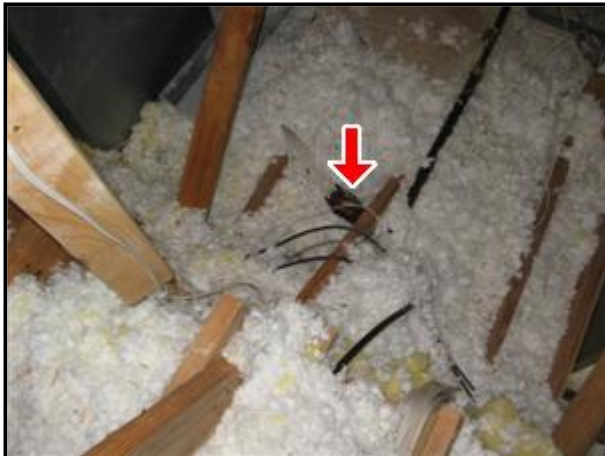
7.3 Picture 1

🏠 There are two junction boxes in the attic that do not have covers on them. Recommend installation of proper cover . This is minor maintenance.

There are two junction boxes in the attic that do not have covers on them. Recommend installation of proper cover . This is minor maintenance.

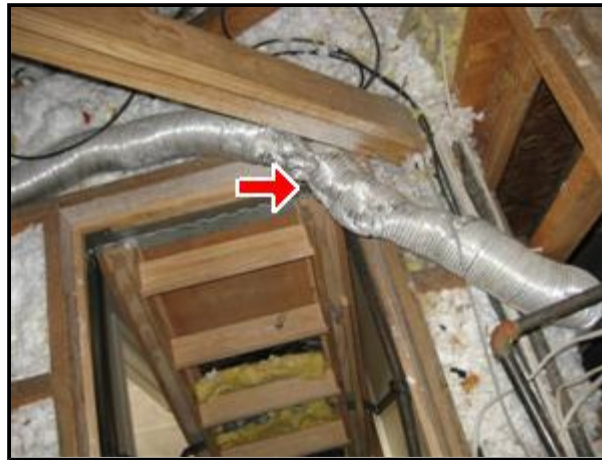
9.2 Picture 1

There is a crushed vent line at the top of the pull down stairs. Recommend repair.
